27 November 2017

GeoWest File: GA17-1083-00

Project: Single Family Residential Subdivision, 43730 Chilliwack Mt. Road, Chilliwack, BC
Subject: Geohazard Site Assessment Report

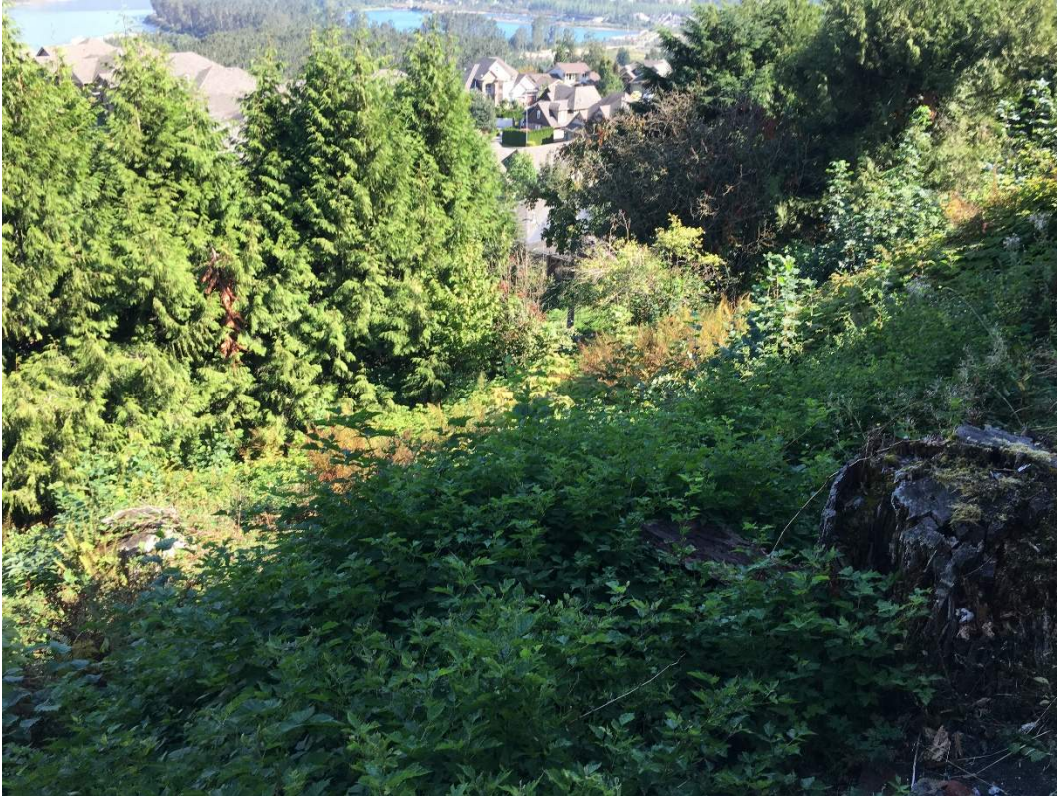
The south portion of the site, occupied by the existing single-family residence and the workshop/garage was relatively flat. An approximately 10 m high slope, inclined at about 30° extended down to the north below the existing residence. The slope is illustrated on Photograph 1. We did not observe evidence of instability on the slope. The existing residence, located along the top of the slope appeared in good condition without visible evidence of settlement. A relatively flat bench extended from the toe of the slope to the north property line along Chilliwack Mountain Road.

Photograph 1. – slope in north region of the site, looking northeast

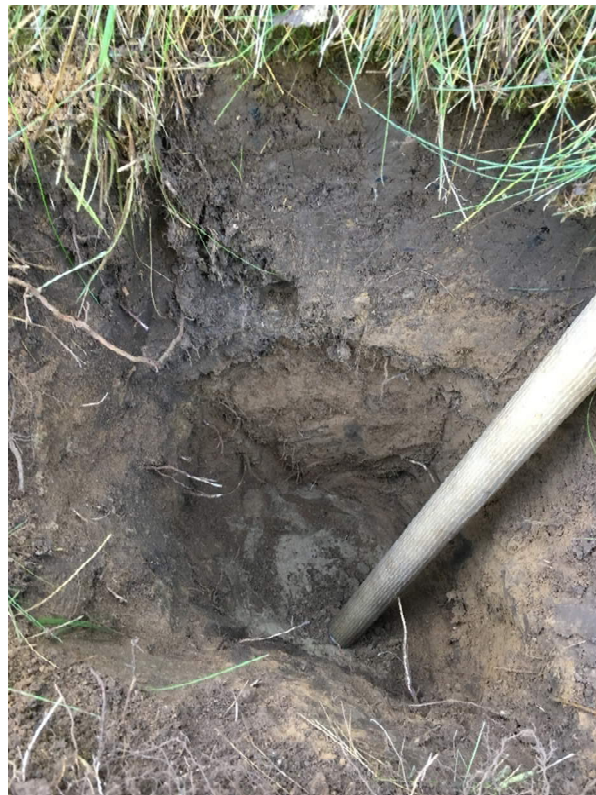
A test pit was excavated by hand on the bench at the toe of the slope to review the near-surface soil conditions. The test pit encountered approximately 150 mm of topsoil, underlain by 0.3 m of soft brown silt (eolian deposits) which was in turn underlain by firm brown-grey silt with trace to some sand. No landslide debris was encountered in the test pit. The soil conditions at the test pit location are illustrated in Photograph 2.

Photograph 2. – test pit

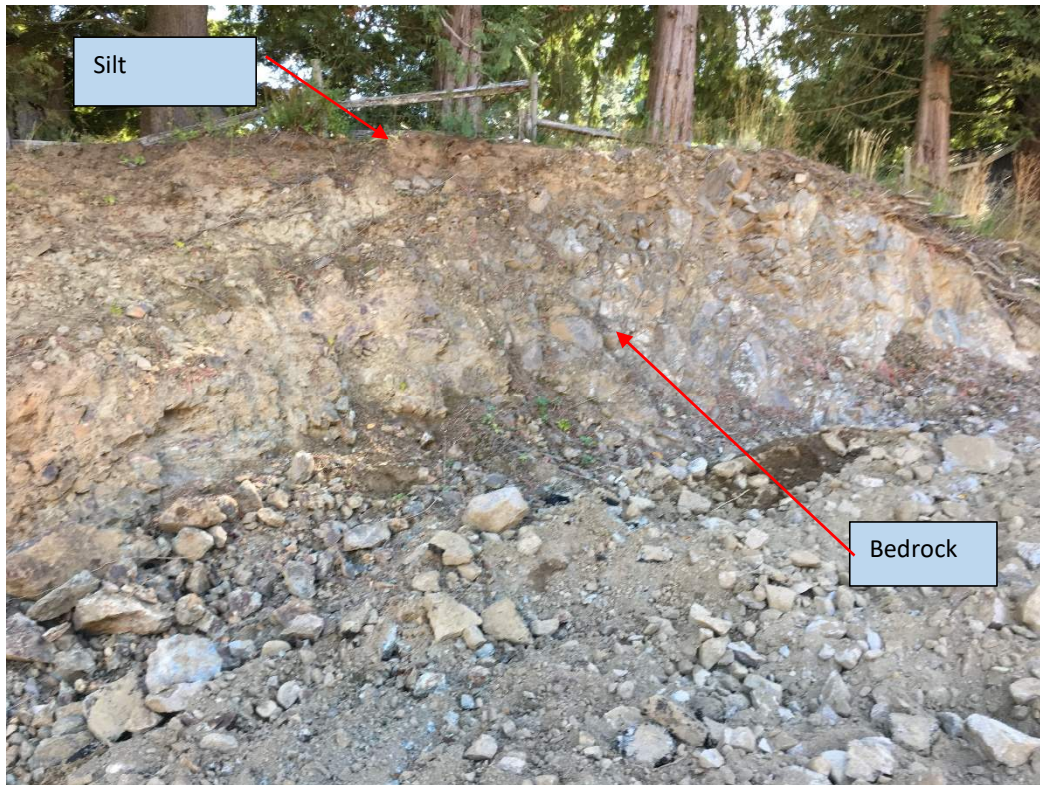
Firm to stiff silt underlain by shallow bedrock was exposed along an existing slope cut along the west property line. The silt layer was over 2 m thick in the northwest corner of the site, becoming less than 0.5 m thick along the central portion of the property line (Photograph 3). We did not observe groundwater seepage along the slope cut at the time of our field work.

Photograph 3. – slope cut along west property line of the site, looking east

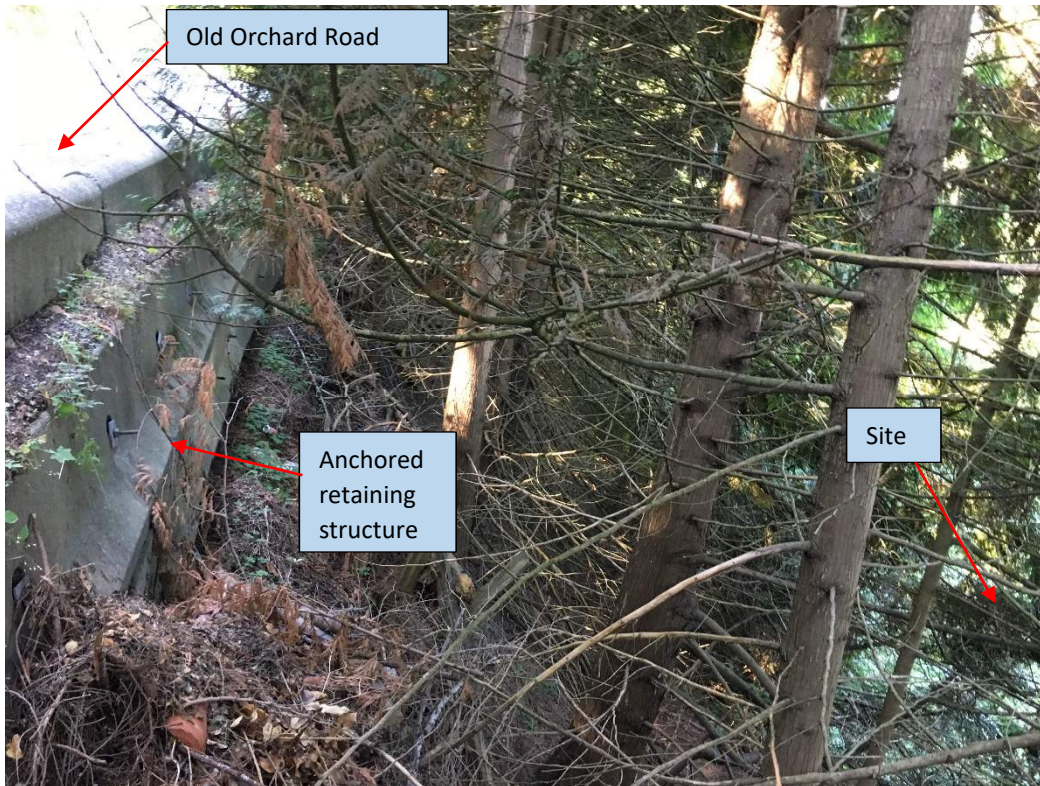
Tension cracks were visible in the westbound lane of Old Orchard Road above the site confirming previous creep and a low degree of stability. An existing two course high retaining wall comprised of concrete barriers extended along the edge of the road atop of the slope. Steel rods and anchor plates on the barriers indicate that the retaining structure is anchored/tied back to provide additional support to the road. The slope and the barriers are illustrated in Photograph 4.

It is our opinion that the small-scale landslide hazard is present at the south end of the site. This hazard is the result of the steep marginally stable condition of the embankment/natural slope that supports the westbound lane of Old Orchard road. The recommended hazard mitigation measures are discussed in Section 6 of this report.

Photograph 4. – slope below Old Orchard Road, looking west

1. The existing slope below Old Orchard Road should be built up to buttress Old Orchard Road and to improve the site accessibility. The recommended maximum inclination of an unreinforced fill slope is 2H:1V along the south end of the site. Retaining walls may also be used.

2. The above fill placement may need to be supplemented with the local stabilization of Old Orchard Road to prevent the westbound lane from failing into the site. The solution used to stabilize the westbound lane should be reviewed with the City of Chilliwack along with the Lot Grading Plan. Furthermore, the actual method used to stabilize this area will depend on the actual position of the property line and driveway entering the site.

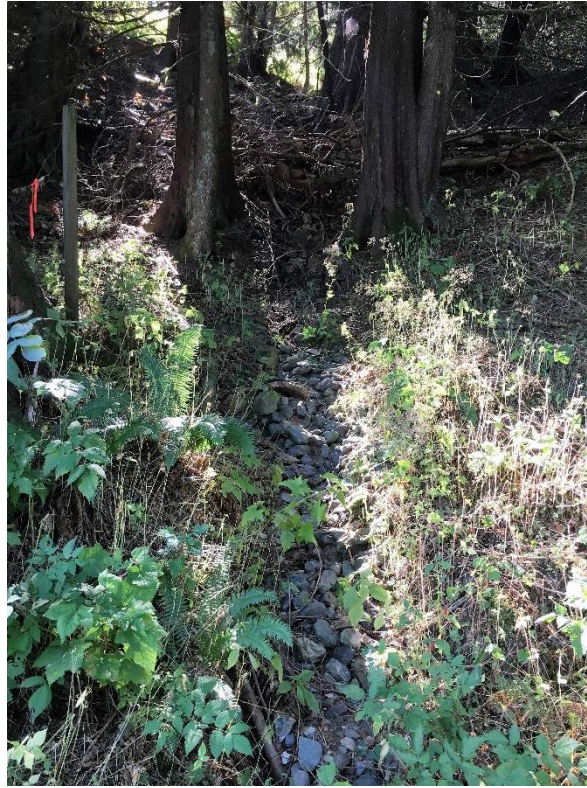
Photograph 5. – ditch above Old Orchard Road
